(NASA-CR-183585) SPACE STATION PROTECTIVE
COATING DEVELOPMENT Final Report (Boeing
Aerospace Co.) 304 p CSCL 22B

SPACE STATION PROTECTIVE COATING DEVELOPMENT

Final Report

**Contract NAS8-36586
January 1989**

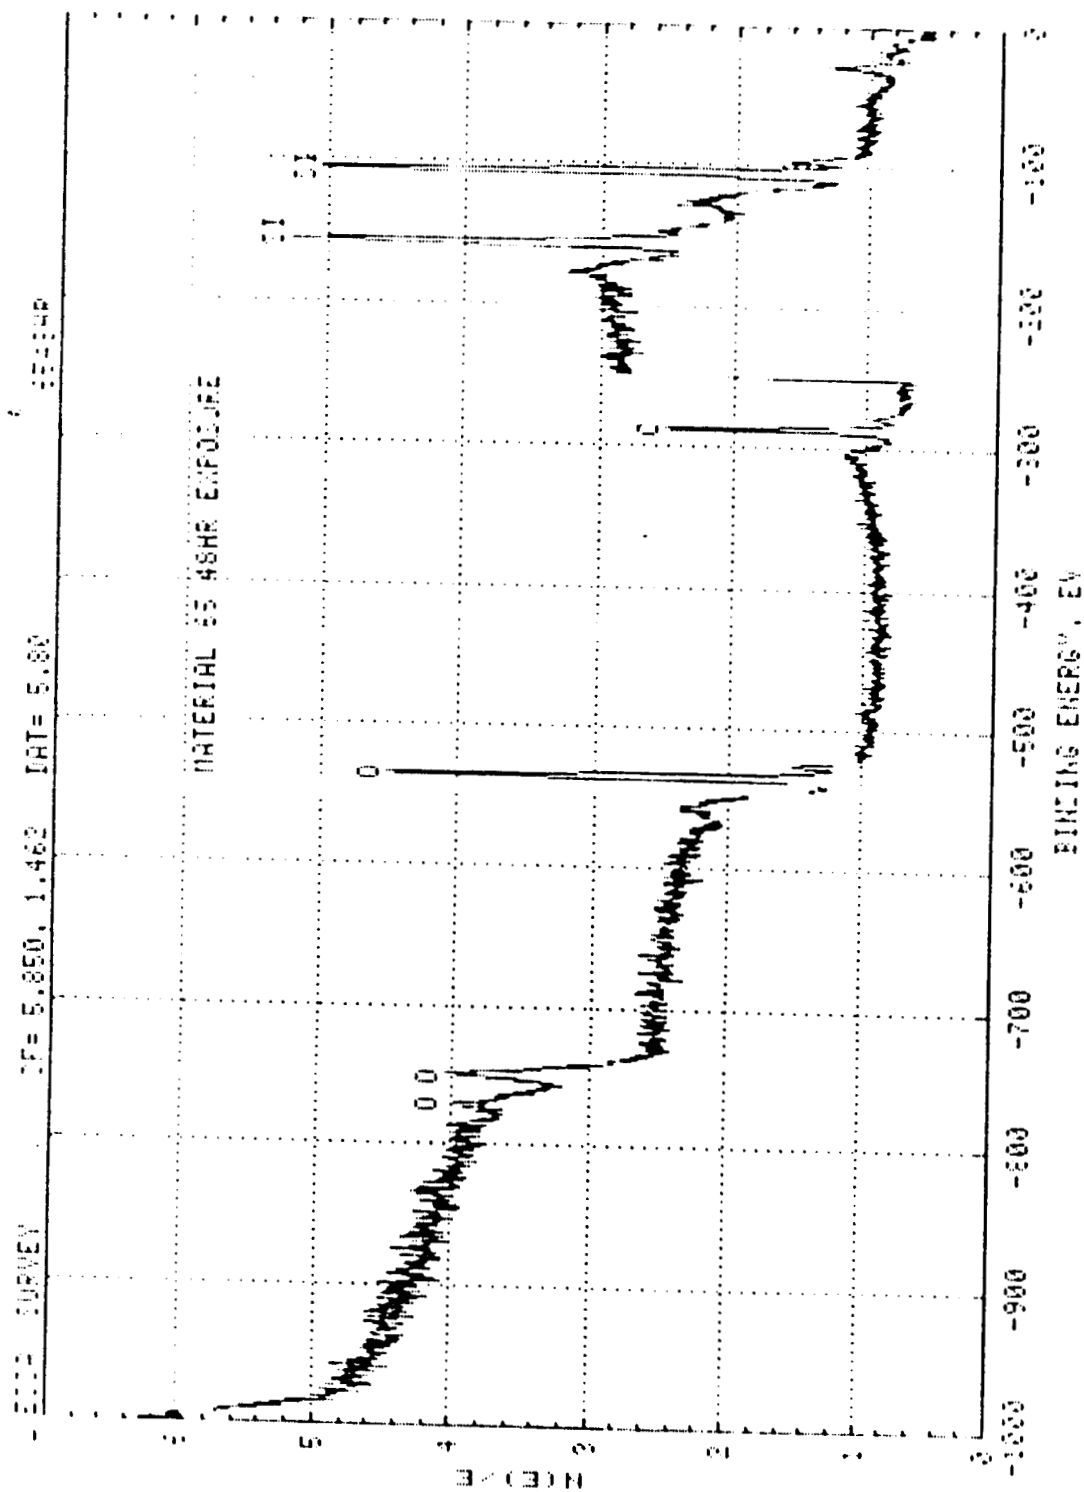
Figure 32: X-Ray Photoelectron Spectrum of Silicone (CV-1144) Coating on Kapton. The Sample was Previously Exposed to Atomic Oxygen for 48 Hours.

Figures 29 through 32 show X-ray photoelectron spectra of a fluorophosphazene, a siloxane-polyimide co-polymer after two different exposures, and a siloxane (CV-1144). Table 33 summarizes the surface elemental analysis for each specimen.

Figure 29 shows that the fluorophosphazene sample contains some silicon peaks, indicating cross-contamination from a siloxane sample being run simultaneously. Because of this evidence of cross-contamination, different material types should not be simultaneously exposed to atomic oxygen. Figures 30 and 31 show the siloxane-polyimide co-polymer after short and long term exposure to atomic oxygen (6 and 51 hours, respectively, December 87-January 88). The data in table 33 show the expected increase in oxygen and silicon relative to carbon. Figure 32 shows results of a repeat of earlier measurements on CV-1144 and shows the expected surface oxidation.

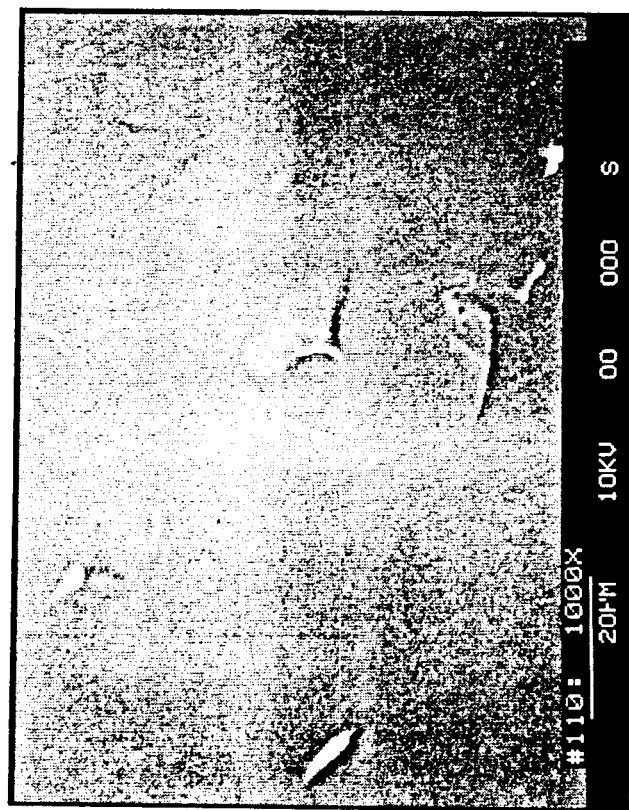
Figure 33: Scanning Electron Micrograph of Plasma Polymerized
Hexamethyldisiloxane

Figure 33 shows photographs scanning electron microscope (SEM) examination of Battelle's Plasma Polymerized hexamethyldisiloxane coating on Kapton. These pictures are typical of many of the better candidate materials. There are few features apparent, the coatings are uniform and there is no evidence of cracking.

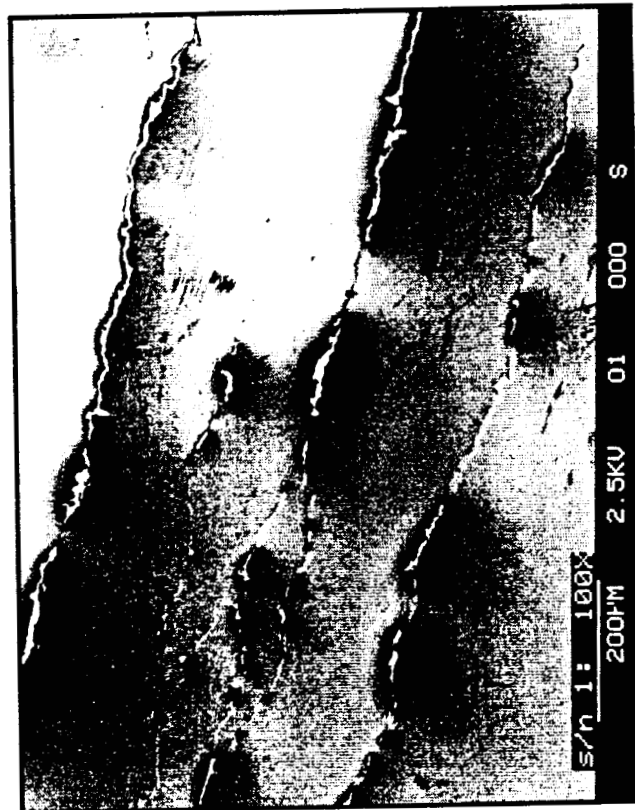
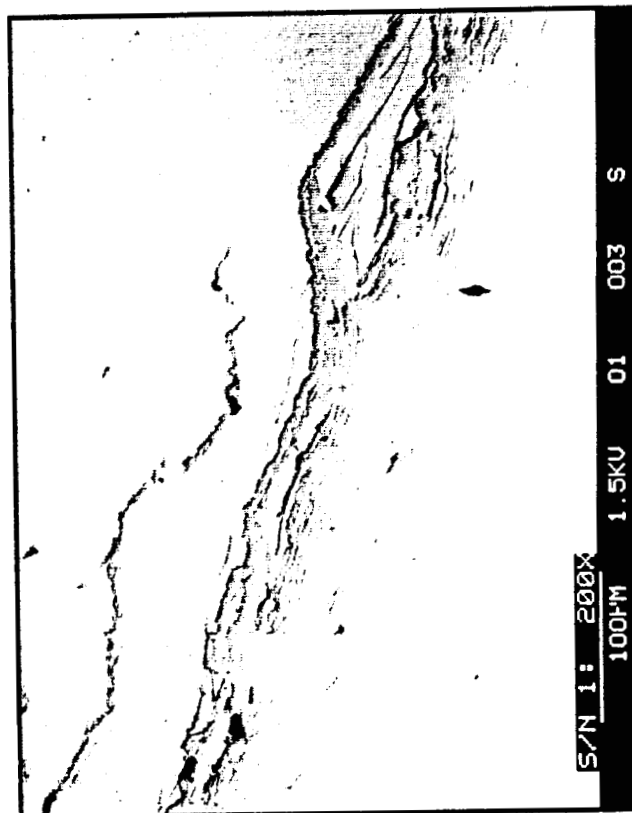
Figure 34: Scanning Electron Micrograph (SEM) of Plasma Polymerized HMDS After Exposure to a Combined Radiation Effects Environment (Electrons, Protons, Simulated Solar UV) and Subsequent Exposure to Atomic Oxygen for 48 Hours.

Figures 34 and 35 are SEM's of Battelle HMDS coatings on Kapton after exposure to a combined radiation effects environment (protons, electrons, simulated solar UV) and subsequent exposure to atomic oxygen for 48 hours, at a flux of about $4-5 \times 10^{16}$ atoms/cm²-sec. These photographs were taken at different resolutions and were made at relatively low electron voltage. There are regions where the coating is gone, areas with cracks which are roughly parallel to one another, and clear evidence of attack on the underlying Kapton. The photograph taken with the electron beam at 2.5 Kilovolts shows electron charging along the cracks, indicating areas where the coating is especially thin. These are the extremely light areas along the cracks.

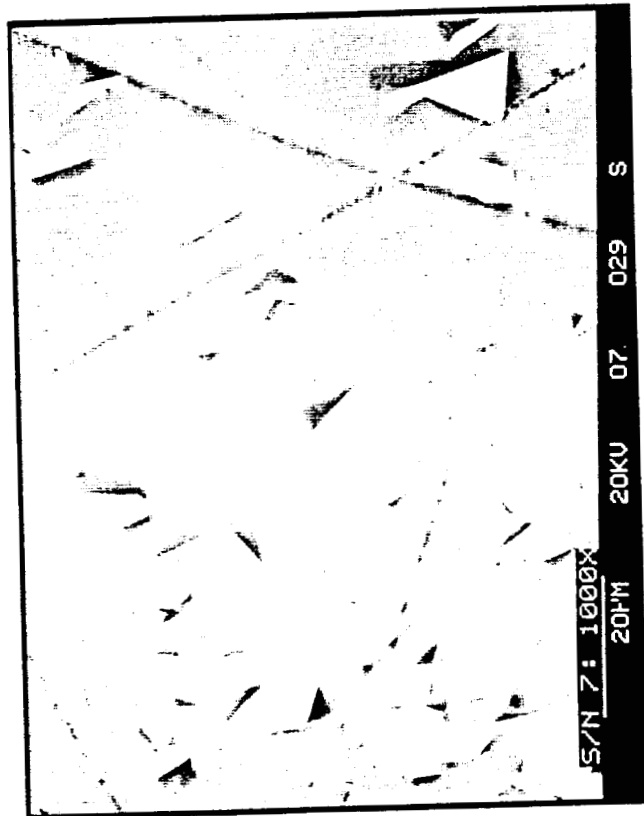
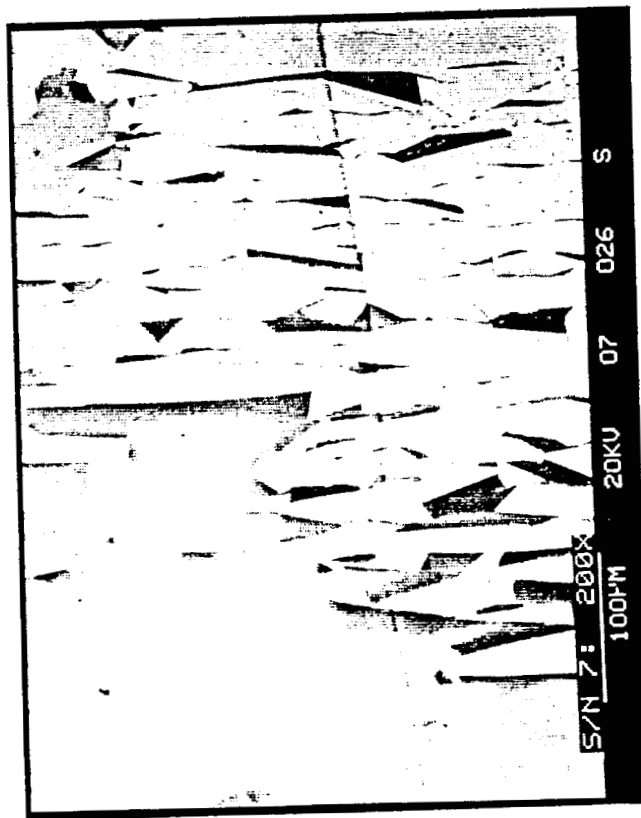
Figure 36: SEM of Kapton After Exposure to a Combined Radiation Effects Environment and Subsequent Exposure to Atomic Oxygen for 48 Hours.

Figure 36 shows an SEM of Kapton after combined radiation effects and subsequent atomic oxygen exposure. The pattern of peeling in the surface layer is of questionable origin. It could be due to peeling along processing marks. It could also be due to surface contamination from coatings on samples exposed simultaneously, although we do not observe this pattern with any coatings which we have examined. It could also be an artifact since an extremely thin palladium coating is applied to the samples to improve the contrast in the SEM.

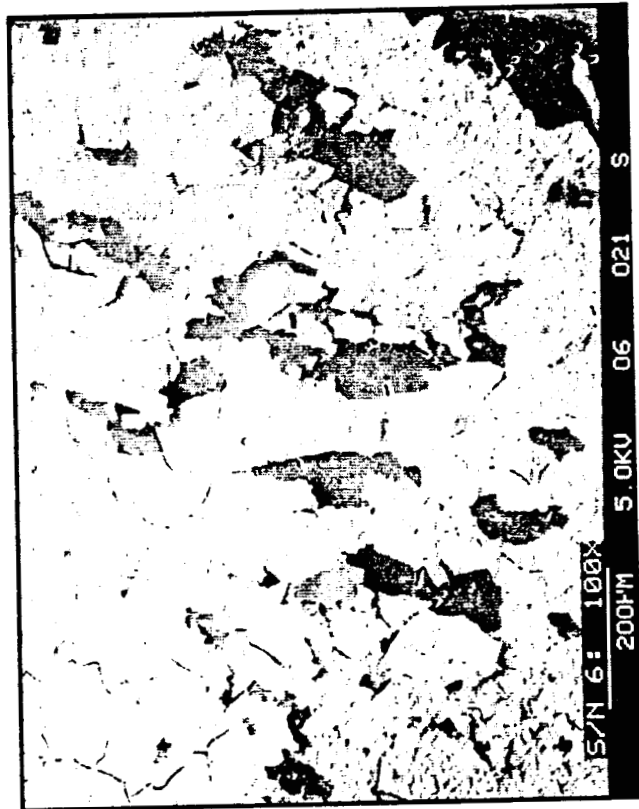
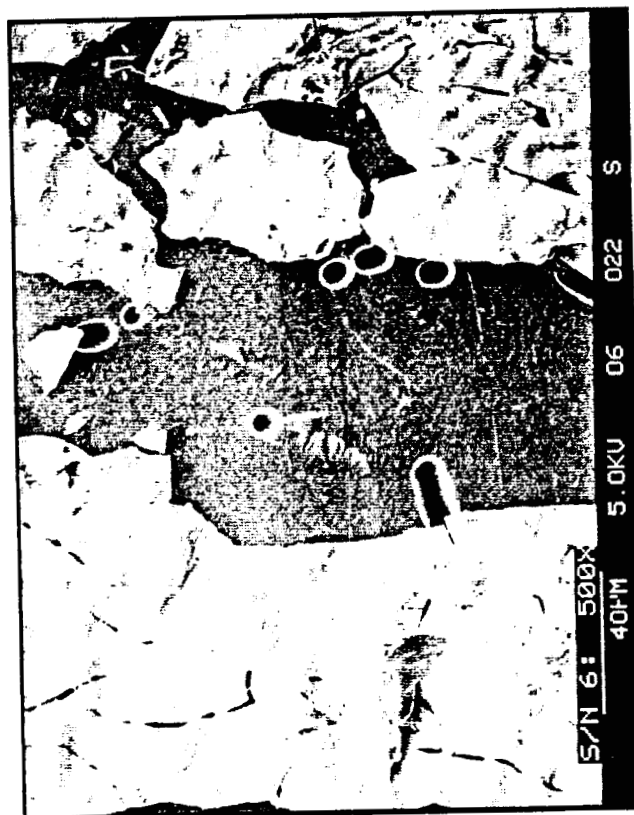
Figure 37: SEM of Fluorophosphazene After Exposure to a Combined Radiation Effects Environment and Subsequent Exposure to Atomic Oxygen for 48 Hours.

Figures 37 and 38 are a sequence of SEM photographs from low to high resolution, showing the cracking, peeling, and loss of distinct regions of a fluorophosphazene coating. This sequence also shows evidence of attack by oxygen atoms through cracks in the coating followed by undercutting along the adhesive bonds between the Kapton and the coating.

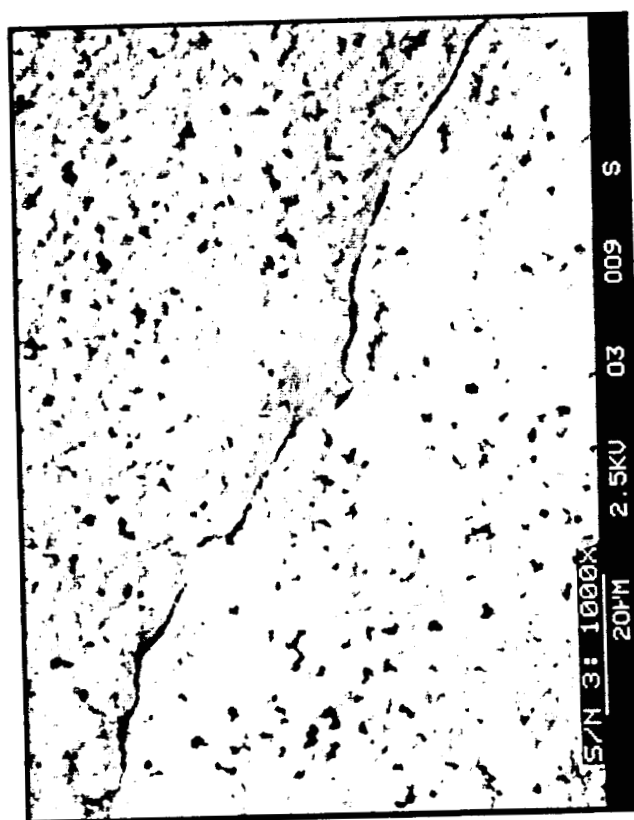
Figure 39: SEM of S13-G/L0 After Exposure to a Combined Radiation Effects Environment and Subsequent Exposure to Atomic Oxygen for 48 Hours.

Figure 39 shows cracking in the S13-G/LO-1 coating after combined radiation effects and atomic oxygen exposure. The porosity of this coating is shown in the higher resolution photograph.

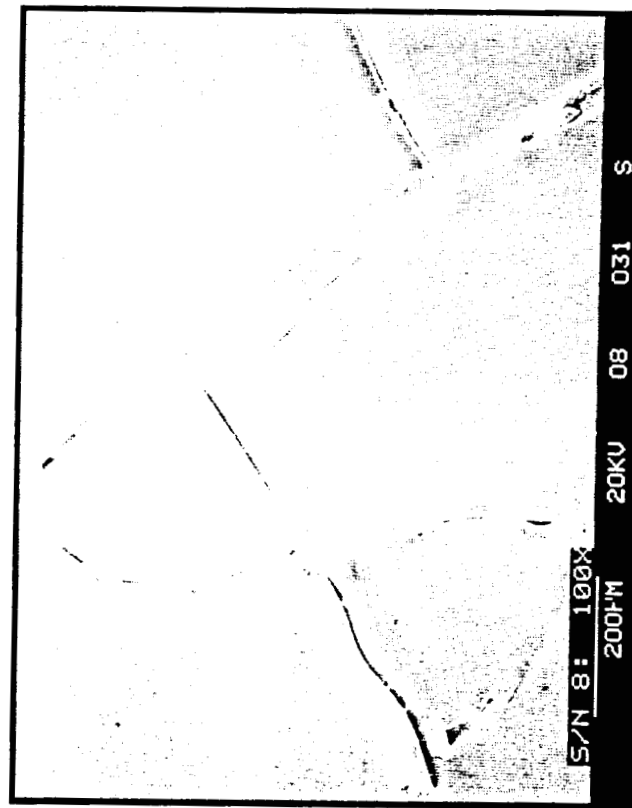
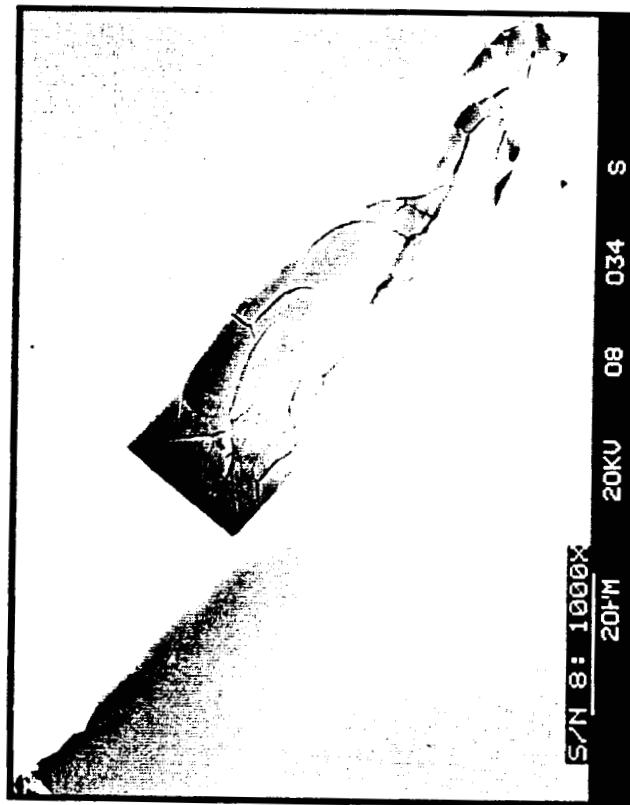
Figure 40: SEM of a Silicone (CV-1144) After Exposure to a Combined Radiation Effects Environment and Subsequent Exposure to Atomic Oxygen for 48 Hours.

Figures 40 and 41 show SEM's of McGhan-NuSil's Silicone and Fluorosilicone coatings, respectively. Cracks are apparent in both these coatings, but especially in the fluorosilicone. The high resolution pictures of both these coatings show electron charging along the cracks just under the coating edges.

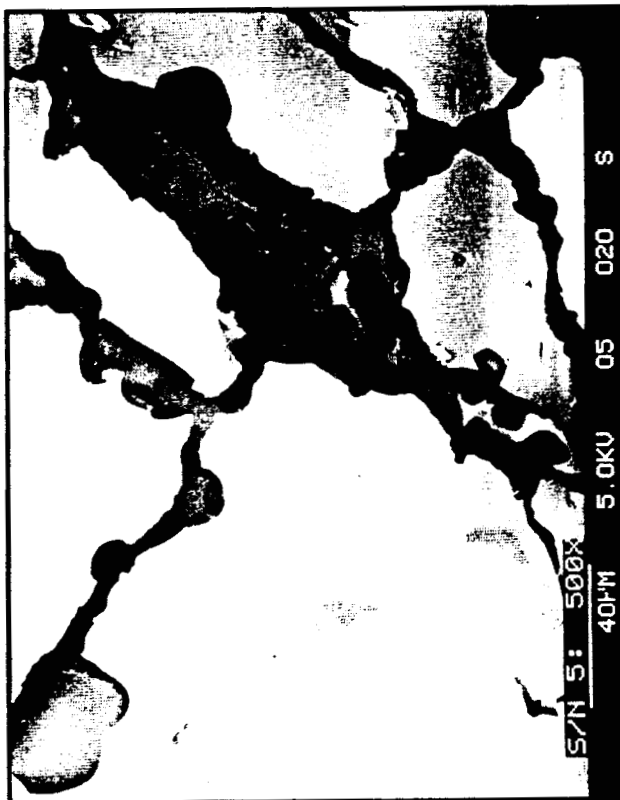
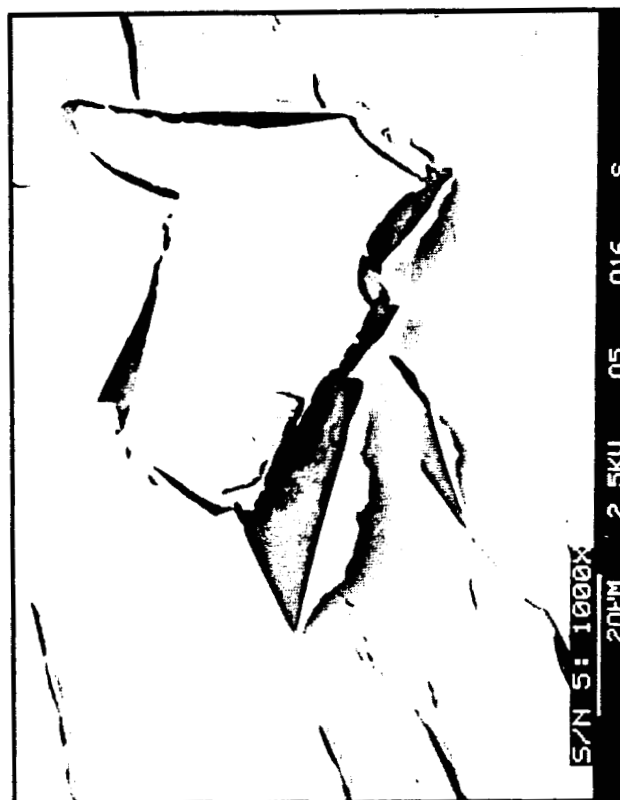
Figure 42: SEM of Plasma Polymerized Hexamethylcyclotrisiloxane/Tetrafluoroethylene (8:1), After Exposure to a combined Radiation Effects Environment and Subsequent Exposure to Atomic Oxygen for 48 Hours.

Figures 42 and 43 are SEM photographs of Battelle's plasma polymerized hexamethyldisiloxane/tetrafluoroethylene coating after combined radiation effects and atomic oxygen exposure. One photo shows blistering, cracking and peeling of this coating. The remaining photographs in these figures are a sequence, each showing the same location, with the electron beam energy being increased. As the electron energy goes up, undercutting beneath the coating, as well as severe degradation of the Kapton substrate are clearly seen.

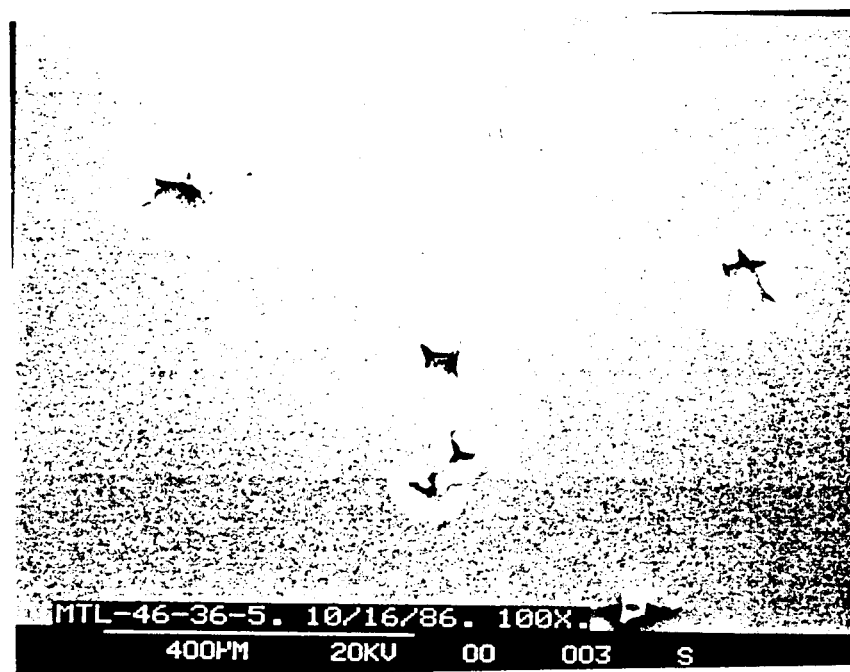
Figure 45: HMDS Coating (#46) on Kapton. Sample Exposed to Atomic Oxygen for 4 Hours.

Material #46: exposed to atomic oxygen (run #36, position 5) 4 hours at 350 watts; Au/Pd-coated for SEM analysis. Title: MTL-46-36-5. Magnification: 100X. Legend: Surface Defects on Atomic Oxygen Exposed Coating. Description: Typical surface defect features resulting from BAC plasma atomic oxygen testing. Note the cracked and peeling surface coating, which exposes the Kapton substrate. The feature at center right shows cracking occurring in the exposed substrate material. Many such defects similar to these were observed over the central region of this sample.

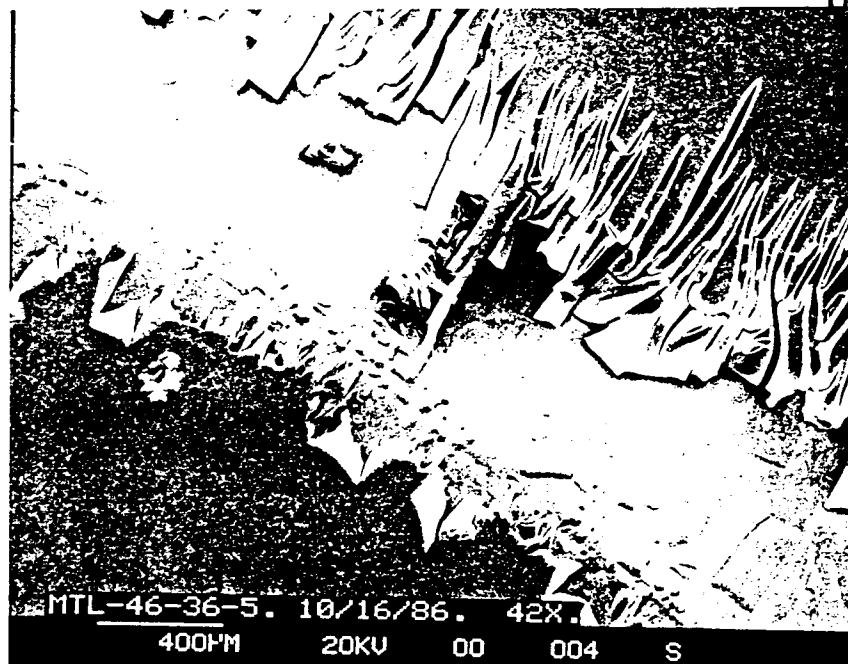
Figure 46: Detail of Damage at Boundary of Exposed and Covered Regions of HMDS Coating After 4 Hours Exposure to Atomic Oxygen.

Title: MTL-46-36-5. Magnification: 42X. Legend: Detail of Outer Ring Damage (Material #46). Description: This is a view of the region where the lip of the aluminum sample holder holds the outer rim edge of the disc material

sample. The splitting of the remnants of the protective coating is more severe on the side held by the aluminum lip, the substrate erosion patterns in the central exposed band region, and the circular pits in the exposed Kapton substrate to the lower center right. The unevenness of the splitting from the exposed side of the band as compared to the aluminum held side is unique, and may be the results of mechanical (compression) or thermal differences.

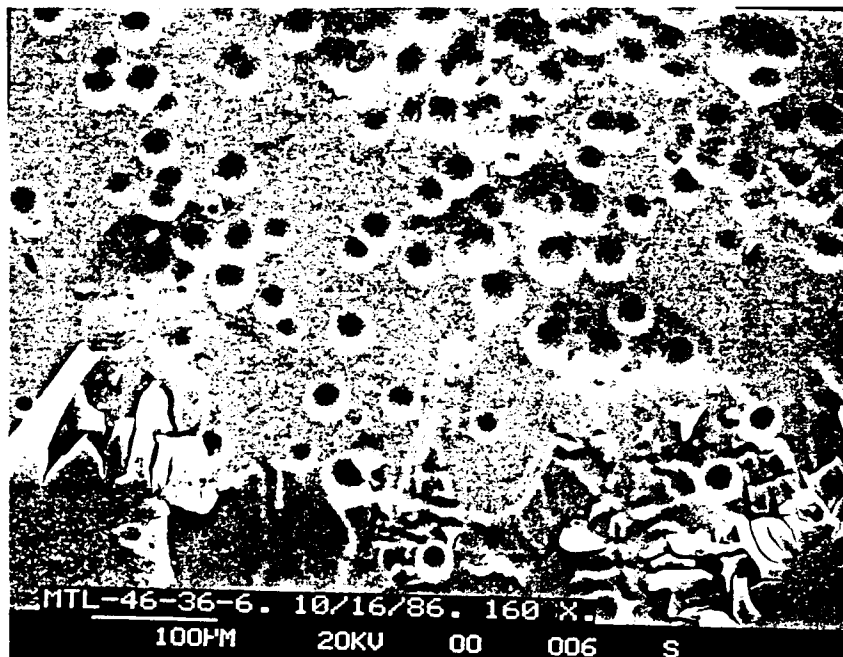
Figure 47: Detail of Area Near Edge of Exposed Region Showing Attack of Kapton Substrate by Atomic Oxygen Upon Coating Loss.

Title: MTL-46-36-6. Magnification: 160X. Legend: Detail of Pit Cluster Area and Surface Erosion Features (Material #46). Description: A close-up showing pits and erosion patterns. Note especially the pits in the lower part of the picture, which appear to have formed after the erosion patterns. If this has occurred, then the pits cannot be the result of surface defects originally in the coating prior to atomic oxygen exposure, but must be due to preferential erosion of the Kapton substrate upon removal of the protective coating and formation of the typical surface erosion patterns.

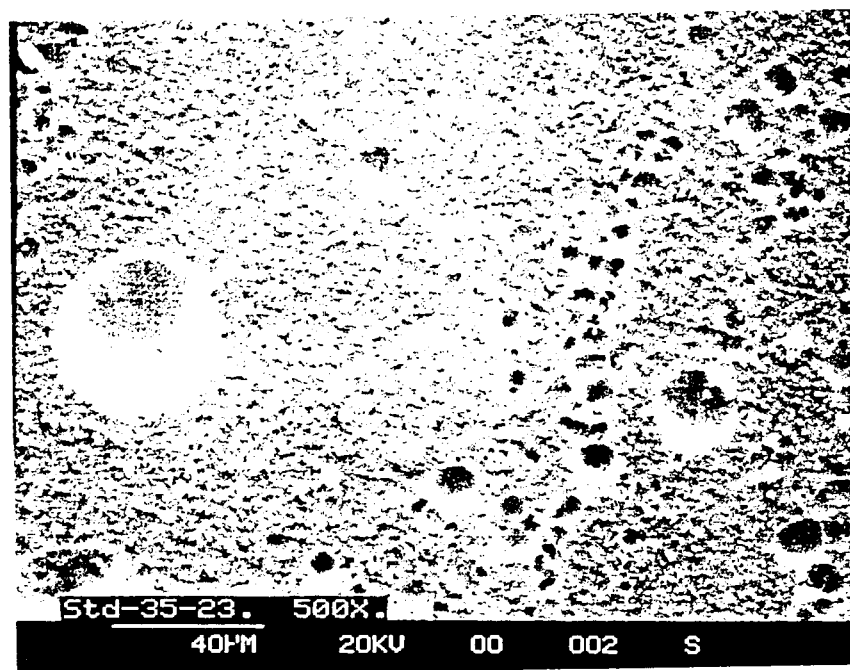
Figure 49: Uncoated 2-Mil Kapton Film After 4 Hours of Exposure to Atomic Oxygen

Standard Material: Kapton 2-mil film, exposed to atomic oxygen (run #35, position 23) for 4 hours at 350 watts; Au/Pd-coated for SEM analysis. Title: Std-35-23. Photo #002. Magnification: 500X. Legend: Typical Surface Features of Kapton Film Standard Material Exposed to Atomic Oxygen in the BAC Plasma Materials Screening Facility. Description: There is a random distribution of pit sizes, and a non-uniform distribution of pits located over the sample, indicating preferential pit initiation sites. There is a uniform scattering of surface debris particles over the sample, which was not observed in the pre-exposure Kapton samples. The atomic oxygen appears to attack the Kapton surface in two separate but simultaneous methods: (1) a general, even surface recession, resulting in a uniform thickness loss over the entire exposed region, and (2) preferential attack and rapid erosion at certain more susceptible sites, resulting in pits and, eventually, hole formation. EDAX (Energy Dispersive X-ray Analysis) spectra were obtained of certain surface features have been obtained. Figure 50 is an EDAX spectrum of a relatively clear, bare area towards the center of the atomic oxygen exposed sample--in the region seen in photo #002- and shows the material in this region to be essentially carbon and oxygen, with slight tracer of aluminum, silicon and zinc (impurities). The gold and palladium peaks are due to the conductive coating sputtered onto the sample for SEM analysis. Figure 51 is an EDAX spectrum taken of the unexposed (protected) rim material of the Kapton sample. Traces of aluminum and silicon are seen as in Figure 50. Comparison of the ratio of peak heights of carbon to oxygen of both figures indicates that the two regions, exposed and unexposed, are essentially the same, with no oxygen enrichment or carbon depletion occurring in the exposed region. Figure 52 is an EDAX spectrum of a large debris particle on the surface, with the exposed area.

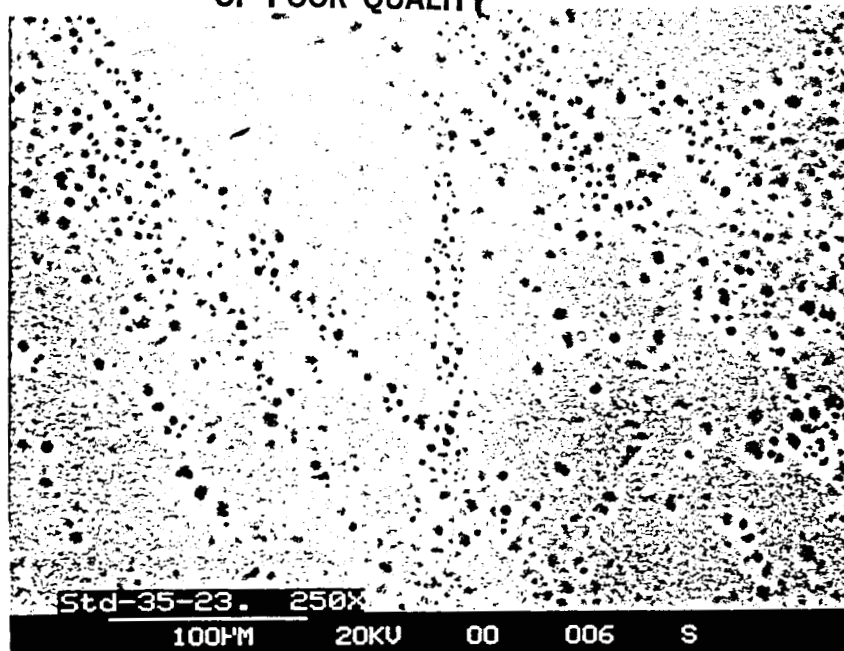
Figure 53: Texture of Uncoated Kapton Film After 4 Hours Atomic Oxygen Exposure

Title: Std-35-23. Photo #006. Magnification: 250X. Legend: Pit Patterns in Atomic Oxygen Exposed Kapton Film. Description: An observed feature of the exposed Kapton film was pit formation. Many of these pits are conical with a dark spot/apex. Others are shallow hemispherical pits. Surface debris, fairly uniform in particle size, is distributed evenly over the surface except where pits have formed. At these sites debris rims a pit but generally no debris is present within the pit. The debris in the pits could not have simply reacted with oxygen atoms and been eroded away as this is not observed for the surface debris present between the pits.

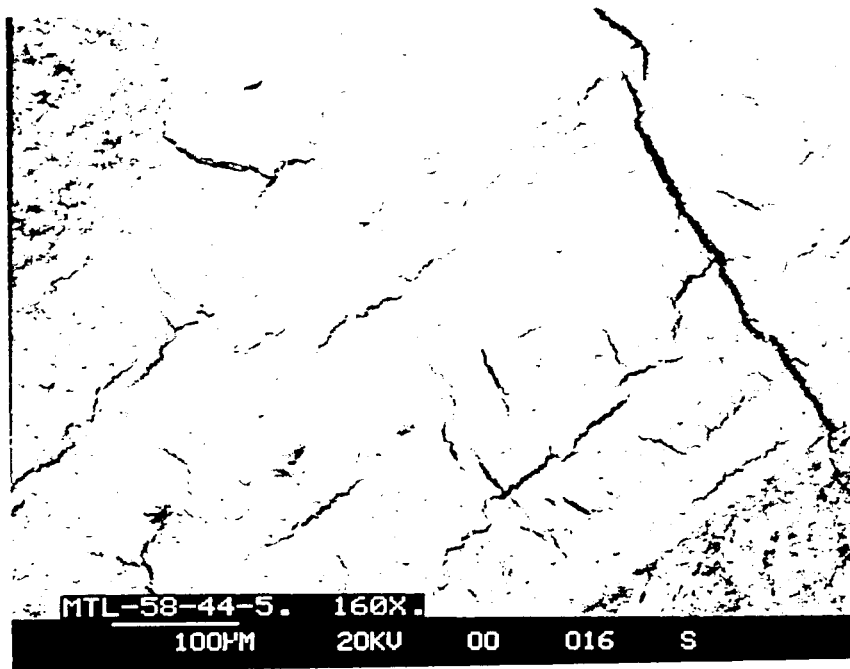
Figure 55: Eypel [®]-Type Coating (X-128) on Kapton. Sample Exposed to Atomic Oxygen Plasma for 2 Hours.

Atomic Oxygen. Description: Typical view of the surface of exposed Material #58. Note uneven distribution of surface debris, and splits in the coating which reveal the Kapton substrate below.

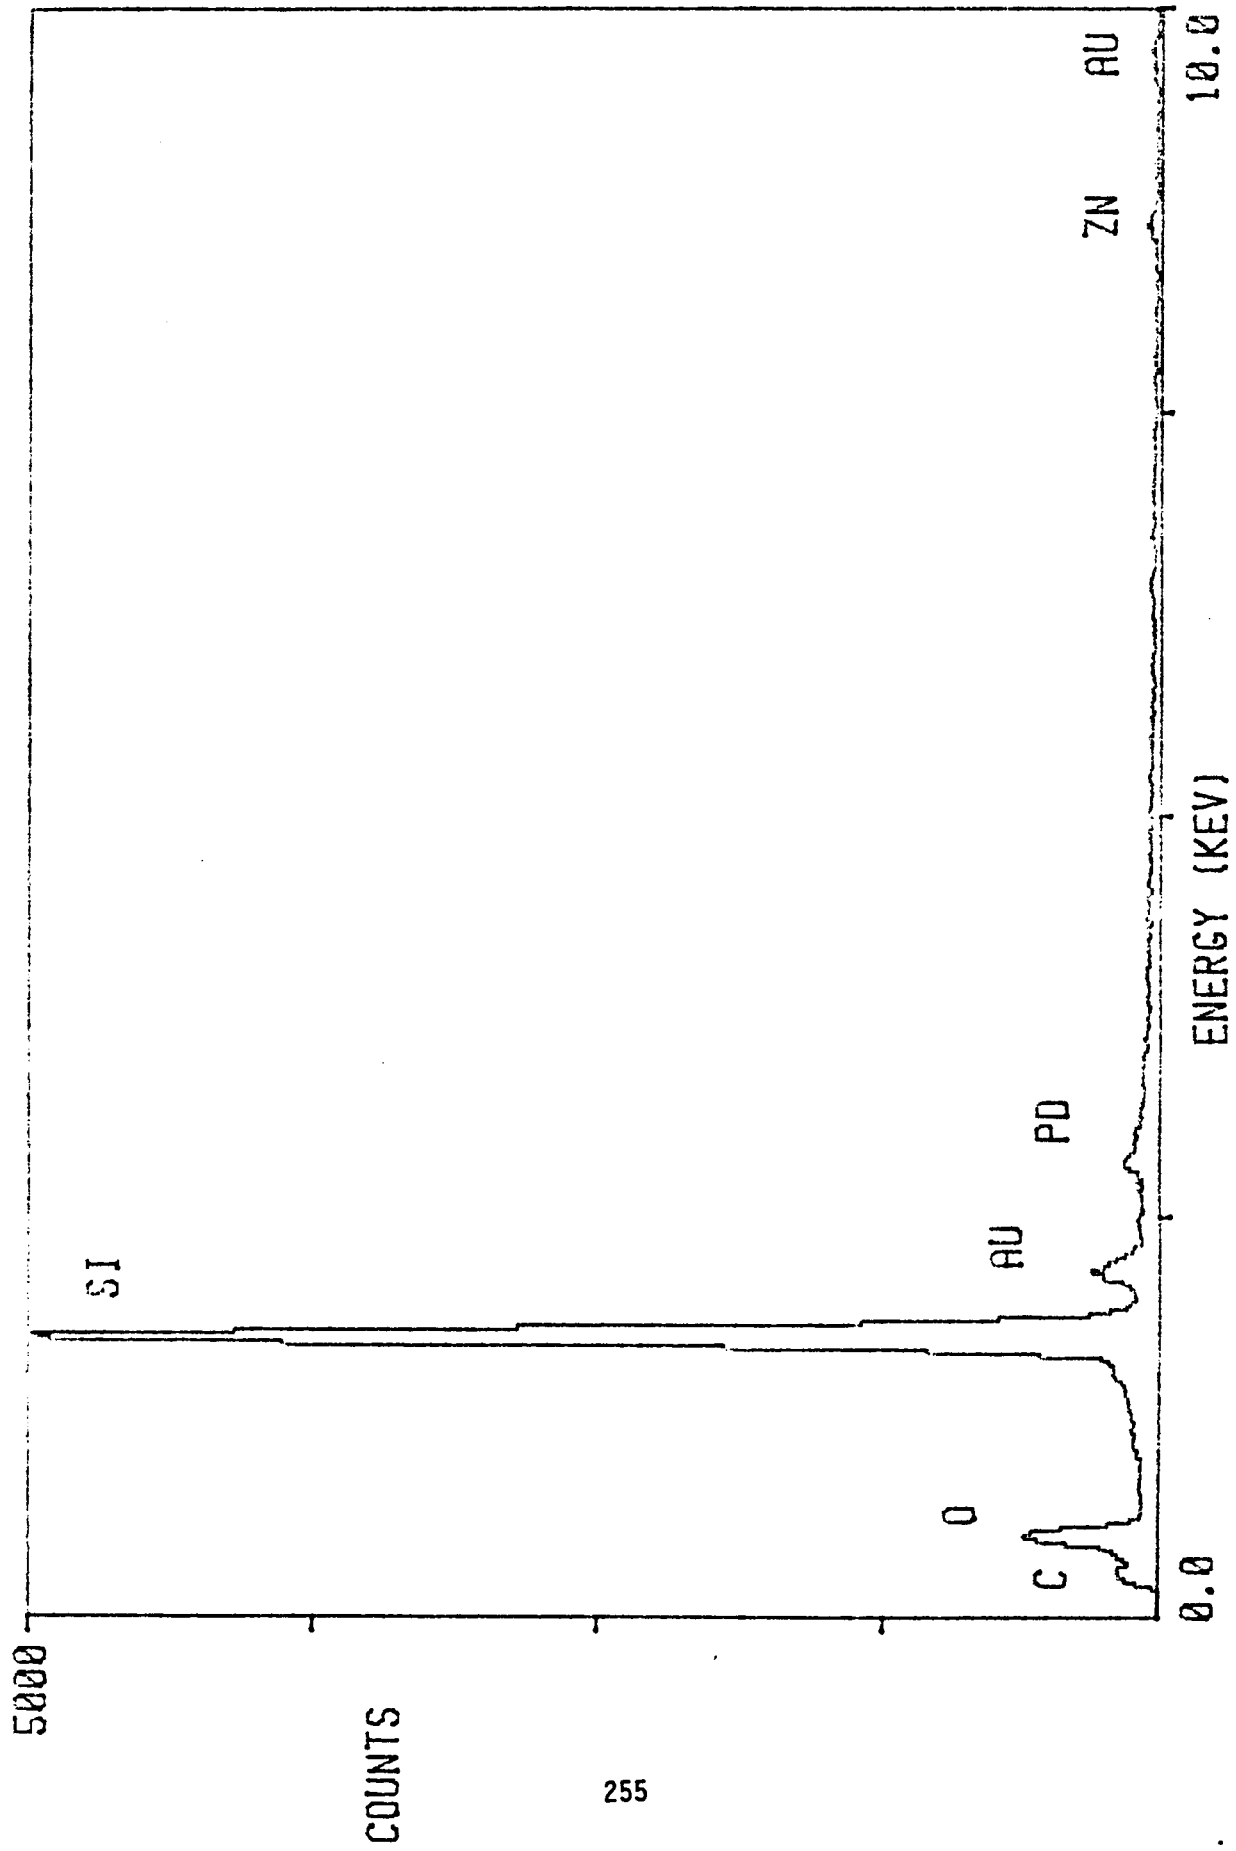
Figure 60: EDAX Spectrum of Unexposed IITRI Silicone Glass coating

application of the coating to the substrate. An EDAX spectrum of the dimpled background is shown in figure 60, and the coating's silicone base is reflected by the strong silicon peak. Traces of zinc and carbon were observed. The carbon may have been present in the silicone used, while the zinc may have been a contaminant from the lab where this sample was sprayed up.

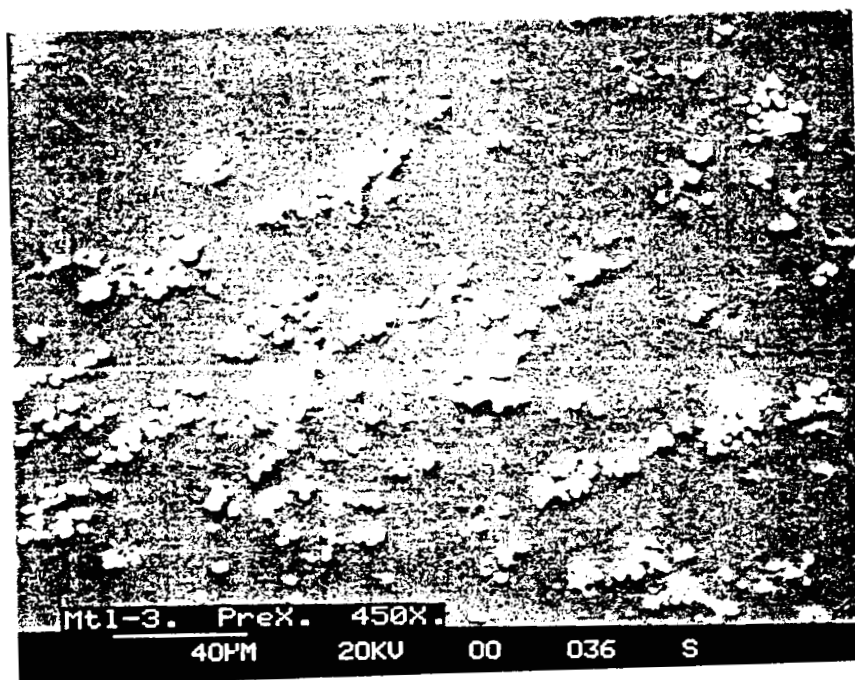
Figure 63: HMDS (#3) on 1-Mil Kapton Film

Figure 63:

Material #3: Battelle plasma polymerized silica (HMDS) on 1-mil Kapton film; unexposed; Au/Pd-coated for SEM analysis. Title: Mtl-3. PreX. Photo #036. Magnification: 450X. Legend: Typical View of Surface of As-Received Plasma Polymerized Silica on Kapton Film. Description: A general view of this coating's surface. An EDAX spectrum of a relatively clear, bare area is shown in figure 64, and the spectrum of a group of spherical surface debris particles is shown in figure 65.

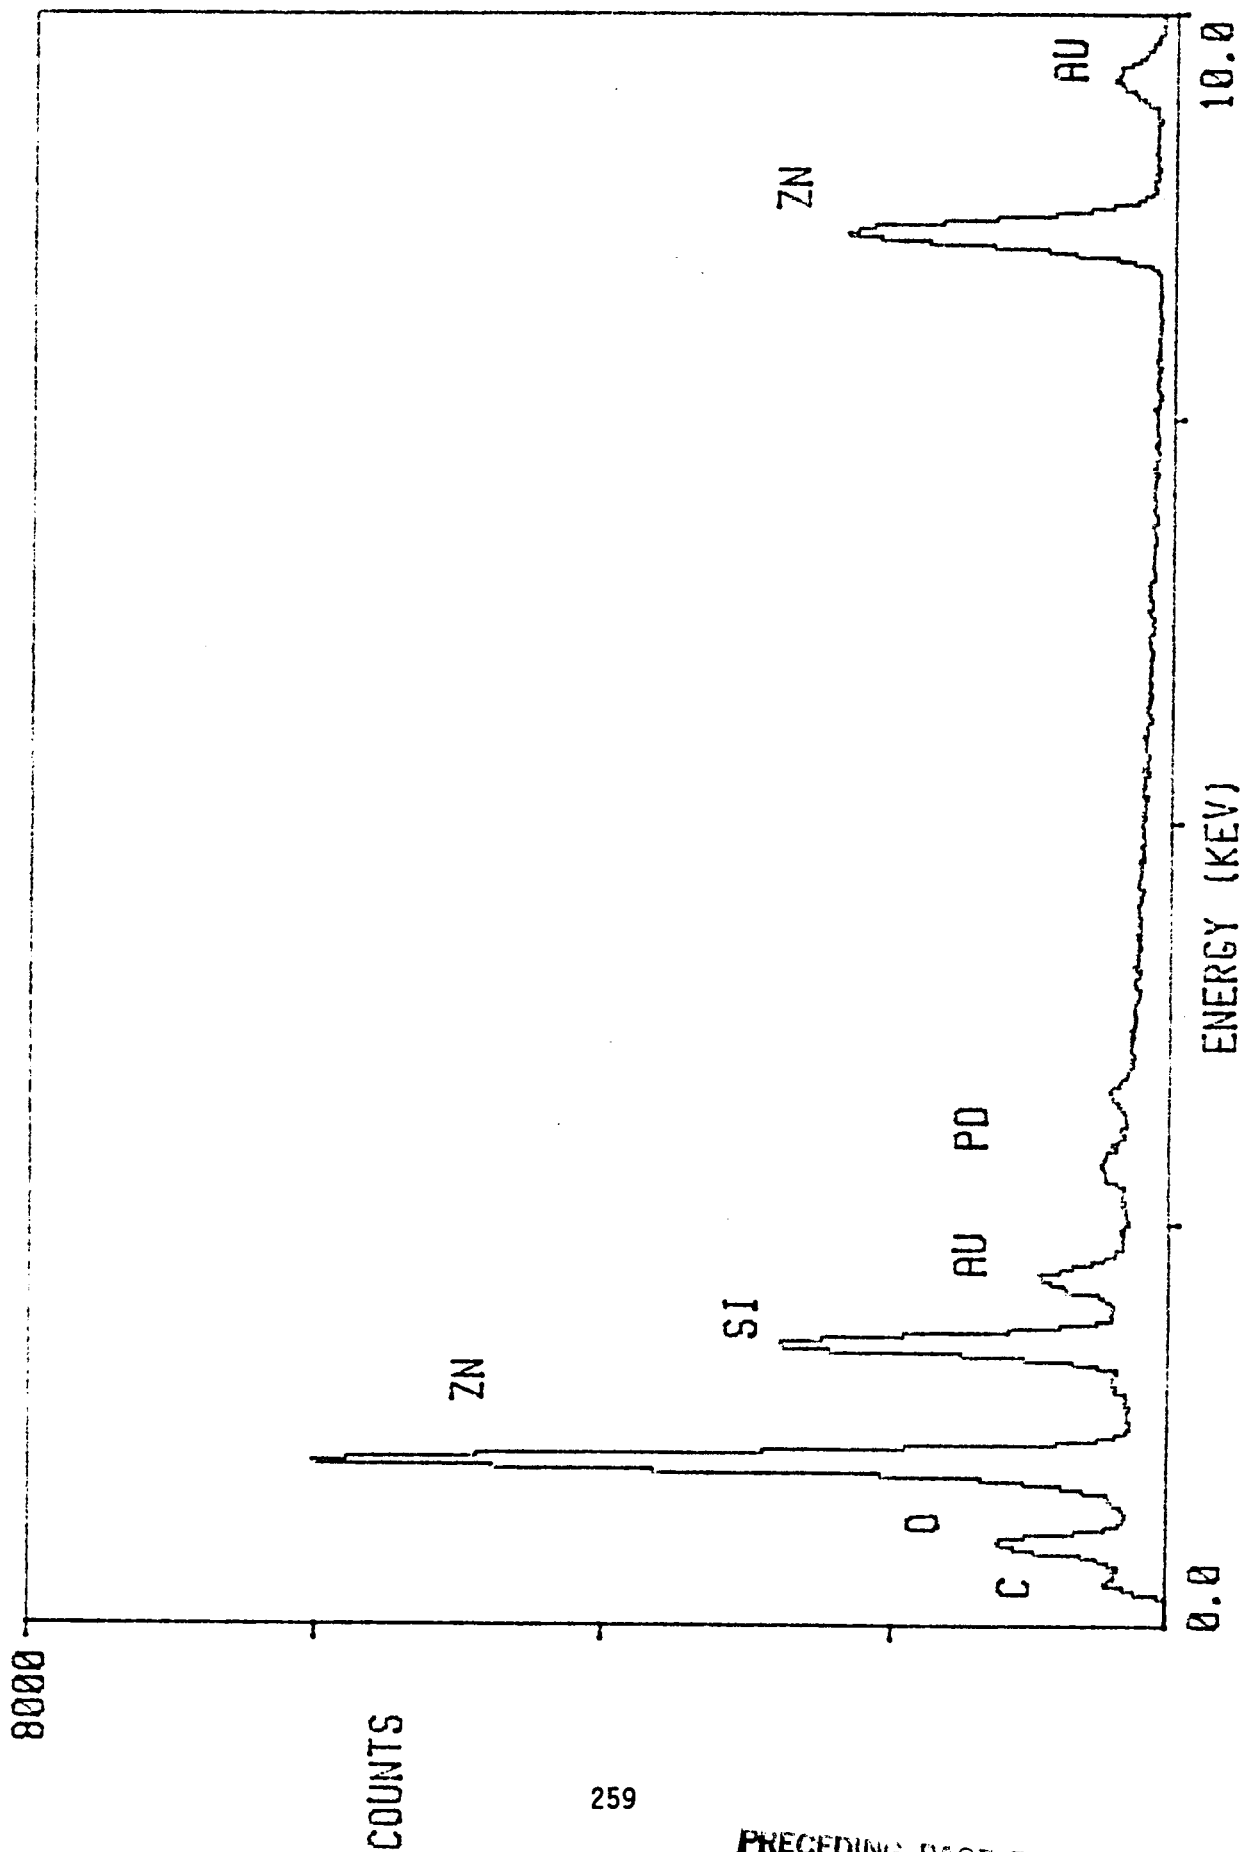
Figure 62: EDAX Spectrum of IITRI S13G/L0-1 on Glass Fiber/Epoxy Substrate

MTL-62. FILLER.

Material #62: ITTRI S13G/L0-1 zinc oxide-filled silicone coating on 40-mil glass fiber/epoxy substrate; unexposed; Au/Pd-coated for SEM analysis. Title: Mtl-62. PreX. Photo #033. Magnification: 1000X. Legend: Typical View of Surface of As-Received S13G/L0-1 Coating on Glass/Epoxy Substrate (Material #62). Description: View of the granular surface of this coating, which is a heavily filled silicone material. The surface appears porous. An EDAX spectrum of the surface is shown in Figure 62, and exhibits strong zinc, and oxygen peaks as expected.

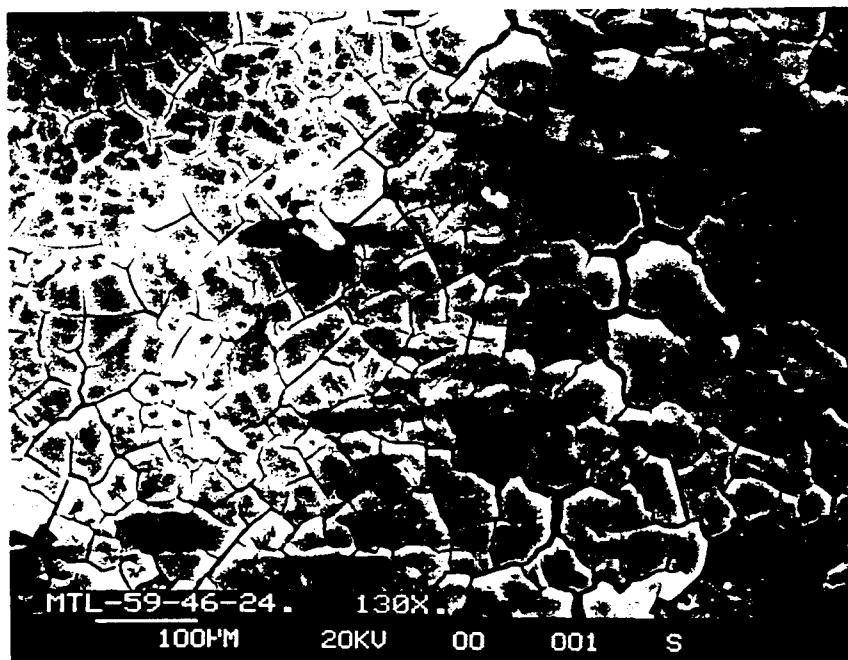
Figure 70: ITTRI Glassy Silicone Coating (#59) on Kapton. Sample Exposed to Atomic Oxygen for 2 Hours.

Figure 70:

Title MTL-59-46-24. Photo #001. Magnification: 130X. Legend: Surface of Atomic Oxygen exposed ITTRI Glassy Silicone Coating (Material #59). Description: A typical view of the surface, showing severe cracking and/or splitting of the coating, and exposed areas of Kapton substrate exhibiting erosion patterns.

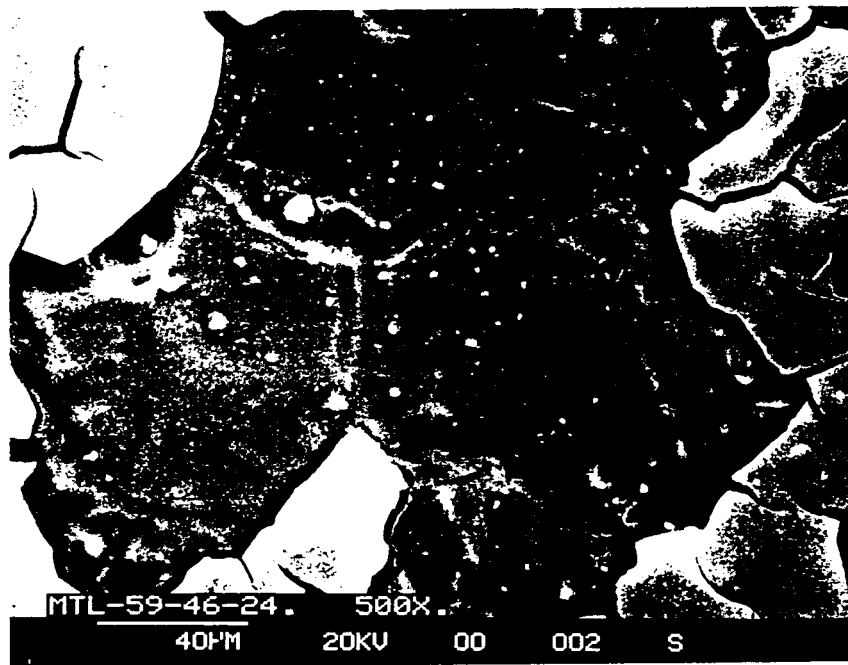
Figure 71: Area of Coating (#59) Loss and Kapton Exposure to Atomic Oxygen Attack

Figure 71:

Title: MTL-59-46-24. Photo #002. Magnification: 500X. Legend: Area of Kapton Substrate Exposed to Oxygen Atom Attack by Loss of Coating (Material #59). Description: An area where the coating has been removed either by oxygen degradation or by handling after exposure. Note the erosion patterns in the Kapton material indicating the locations of splits or cracks in the original surface coating prior to coating removal. Note formation of pits in the exposed substrate.

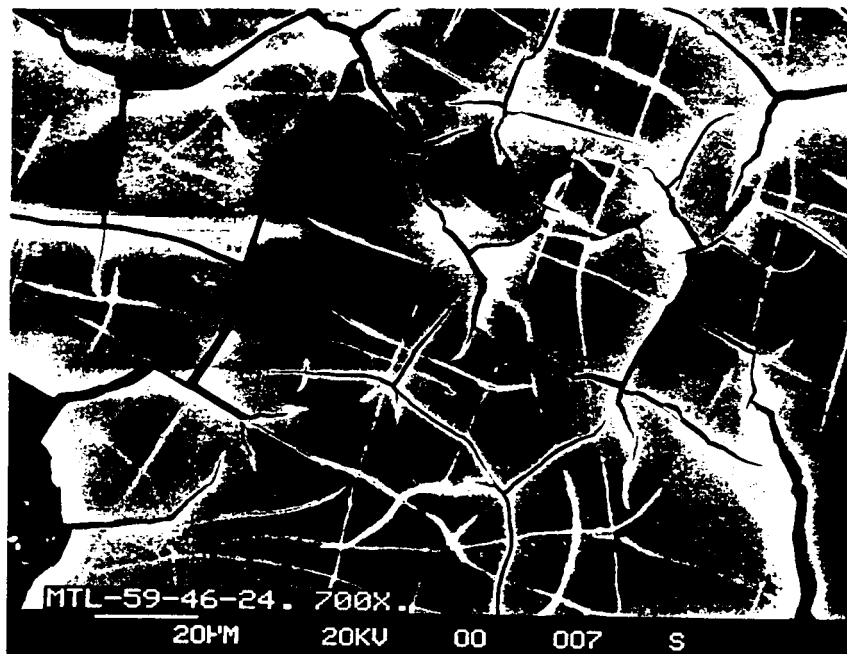
Figure 72: Localized Charging Along Cracks in Coating Material (#59) Subsequent to Atomic Oxygen Exposure

Figure 72:

Title: MTL-59-46-24. Photo #007. Magnification: 700X. Legend: Localized Charging on Exposed Coating Surface Showing Initial Crack Formations (Material #59). Description: Although sputter-coated with gold/palladium for analysis, localized charging from the SEM electron beam was observed. This charging, seen here as contrast changes, revealed the presence of very fine cracks or fractures in the larger segments of coating material. The EDAX spectrum of an exposed coating specimen is shown in figure 73, and can be compared to the spectrum of the unexposed coating shown in figure 60. The exposed coating contains a significantly higher level of oxygen, with no other changes in composition apparent. This indicates a silicone-to-silica oxidation process has occurred.

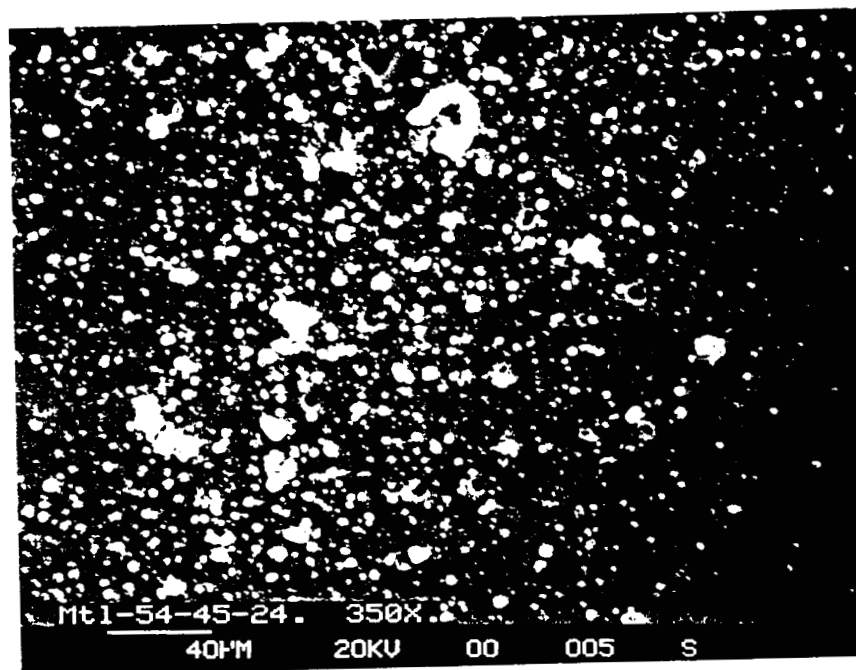
Figure 75: Clouded Region of HMDS/TFE Coating (#54) on Kapton

Figure 75:

Title: Mtl-54-45-24. Photo #005. Magnification: 350X. Legend: Surface of Clouded Region on Plasma polymerized HMDS/TFE (Ratio 8/1) Coating (Material #54). Description: Streaks of clouded areas could be observed on this sample at low magnification. Examination of one of these streaks reveals the cloudiness to be high levels of particulate debris on and in the coating surface. EDAX analysis of the debris and the bare (clean) coating surface (figures 76 and 77, respectively) showed the elemental compositions to be similar, with the debris having a slightly higher level of carbon. No traces of fluorine are observed. Fluorine should be present due to the TFE (tetrafluoroethylene) component of the coating. Fourier Transform Infrared (FTIR) spectrometry (figure 78) of the coating also failed to unambiguously detect fluorine-containing species in the coating's molecular structure. The coating's IR spectrum is similar to that of a typical commercial dimethyl silicone formulation, and lacks the peaks present in the spectrum of a typical TFE formulation. While the TFE content of this coating is low, according to the supplier's data, the FTIR and EDAX should have easily detected the fluorocarbon

component. From the EDAX and FTIR data therefore, it appears that no TFE is present in any form in this coating material. From previous EDAX analysis of similar plasma polymerized coatings from the same supplier, similar failures to detect the presence of fluorine in the coatings indicates that none of these plasma prepared materials contain significant levels of fluorocarbon components.
